International Operational Modal Analysis Conference

20 - 23 May 2025 | Rennes, France

OMA of a School Building Damaged by the Illapel Earthquake (Chile 2015)

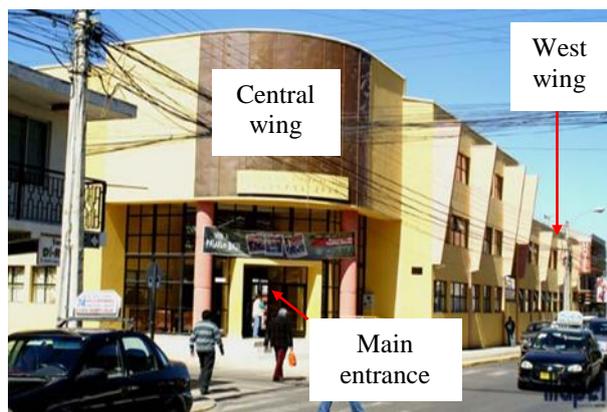
(a) General view

The plan layout displayed in Figure 1.b shows that three wings make up the building; they are separated by seismic joints (indicated with green lines). The central wing has three stories and an L-shaped plan, and the external wings have two stories and are rectangular, being attached to both ends of the central one. Figure 1.a displays the main entrance to the building, which is located in the corner of the central wing. This paper focuses mainly on the central wing, which was the most damaged during the earthquake. The total height of the buildings is approximately 9.5 m and the plan area of the central wing is approximately 360 m². The structure consists of 3-D RC moment-resisting frames consisting of columns, beams, and slabs. Infill walls are made of unconfined and unreinforced masonry [4]. Noticeably, most of them are incomplete (i.e., do not encompass the full height of the story leaving a top opening useful for lighting); this leads to many short (captive) columns, extremely detrimental to the building's seismic performance. In fact, the damage was mainly concentrated in some of the short columns of the first and second levels. The construction quality is generally poor, and most probably does not fulfill the Chilean seismic design code [5].

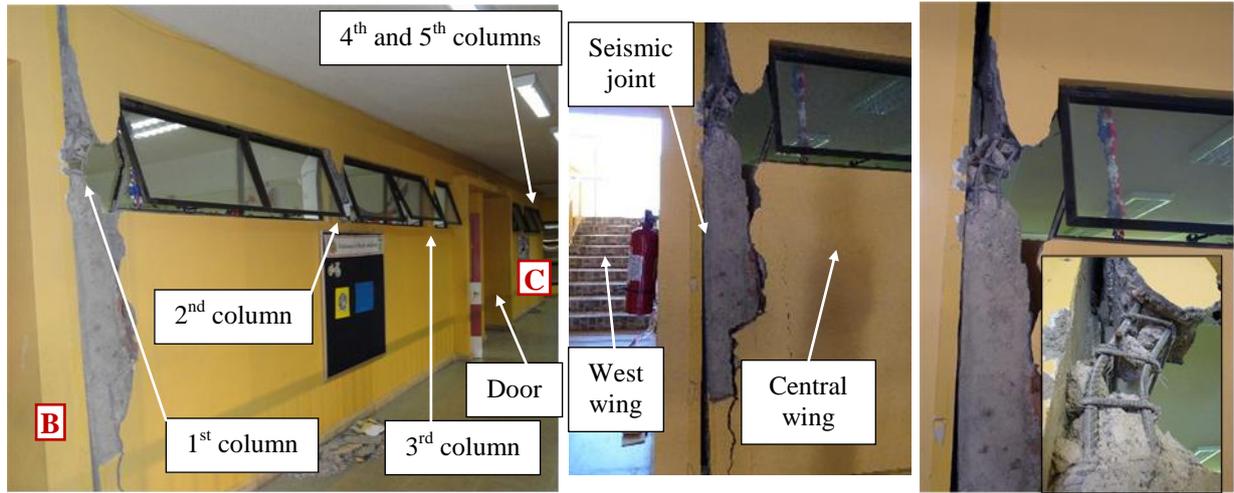
(a) General view

This section describes the damage observed during the post-event visit. Figure 2 illustrates the itinerary (B-E) inside the central wing and Figure 3 displays images of the observed damage in the segment BC of this circuit. Figure 3.a exhibits an overview of segment BC and the following Figures (Figure 3.b through Figure 3.g) present details of the observed damage. The cases depicted in Figure 3 are representative examples of many similar situations occurring in other locations inside the building. Figure 3.a shows that the incomplete interior wall has five short columns connecting this wall to the upper slab; also, the two-door jambs play a similar role. Figure 3.b to Figure 3.f confirm that all columns experienced similar levels of damage; the last (fifth) column did not exhibit any apparent damage, but Figure 3.g shows that the sill wall separated from the adjoining column, thus breaking its captive condition. This trend is expected in any short column alignment, as they all experienced roughly the same transverse distortion; however, the drift appeared in the direction of the wall and also in the orthogonal.

Figure 3. Observed damage to segment BC (Figure 2) of the inspection itinerary. Central wing

Figure 3.b to Figure 3.f indicate that all the columns are rather similar; externally their section is 20 cm × 30 cm, and their “core” (concrete kern confined by the transverse reinforcement) is approximately 12 cm × 12 cm. The longitudinal reinforcement consists of four 16 mm diameter bars and 6- or 8-mm stirrups separated 12 cm; this core is insufficient, being smaller than indicated in the design (square of 17 cm on each side), and its shear and bending strength is severely diminished. On the other hand, the quality of the concrete seemed pretty bad; some important cavities were even observed. Finally, it should be highlighted that the observed damage revealed that relevant torsion occurred; this consideration is because the farthest column from the center of rotation (Figure 2) exhibited the worst damage and Figure 3 shows significant horizontal displacements orthogonal to the wall plane. This trend corroborates the considerations from Figure 2. Figure 3.b to Figure 3.f show that the columns failed by shear rather than bending; this is expected, as they are highly short (stocky). The conditions of each column are discussed in more depth next. Figure 3.b and Figure 3.c refer to the first column, apparently the most damaged. Figure 3.b shows that this column is adjacent to the seismic joint that separates the west and central wings. Figure 3.b and Figure 3.c highlight that the lowest segment of the column rotated to the left until it collided with the west wing and generated some pounding; the upper column segment (the most damaged) failed due to spalling and subsequent destruction of the concrete core and buckling of the longitudinal rebars. Noticeably, in the first column, the transverse reinforcement was made of 8 mm diameter bars and did not fail. On the other hand, the first column exhibited lateral displacement in both horizontal directions; this is coherent with the high eccentricity

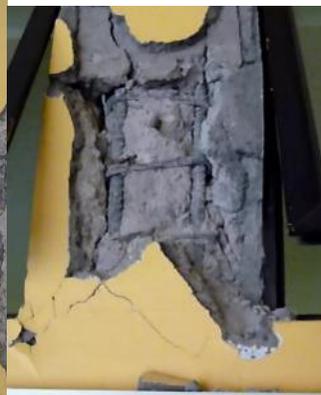
(f) Fourth column

between the centers of mass and of rotation displayed in Figure 2. Regarding the other columns, Figure 3.d shows that the second column had a shear failure; the separation of the stirrups in the affected segment was particularly high. Analogously, Figure 3.e and Figure 3.f confirm that the third and fourth columns also failed due to shear, although without breaking the transverse reinforcement.
