International Operational Modal Analysis Conference

20 - 23 May 2025 | Rennes, France

Integrated structural condition assessment of an ancient Mayan Temple

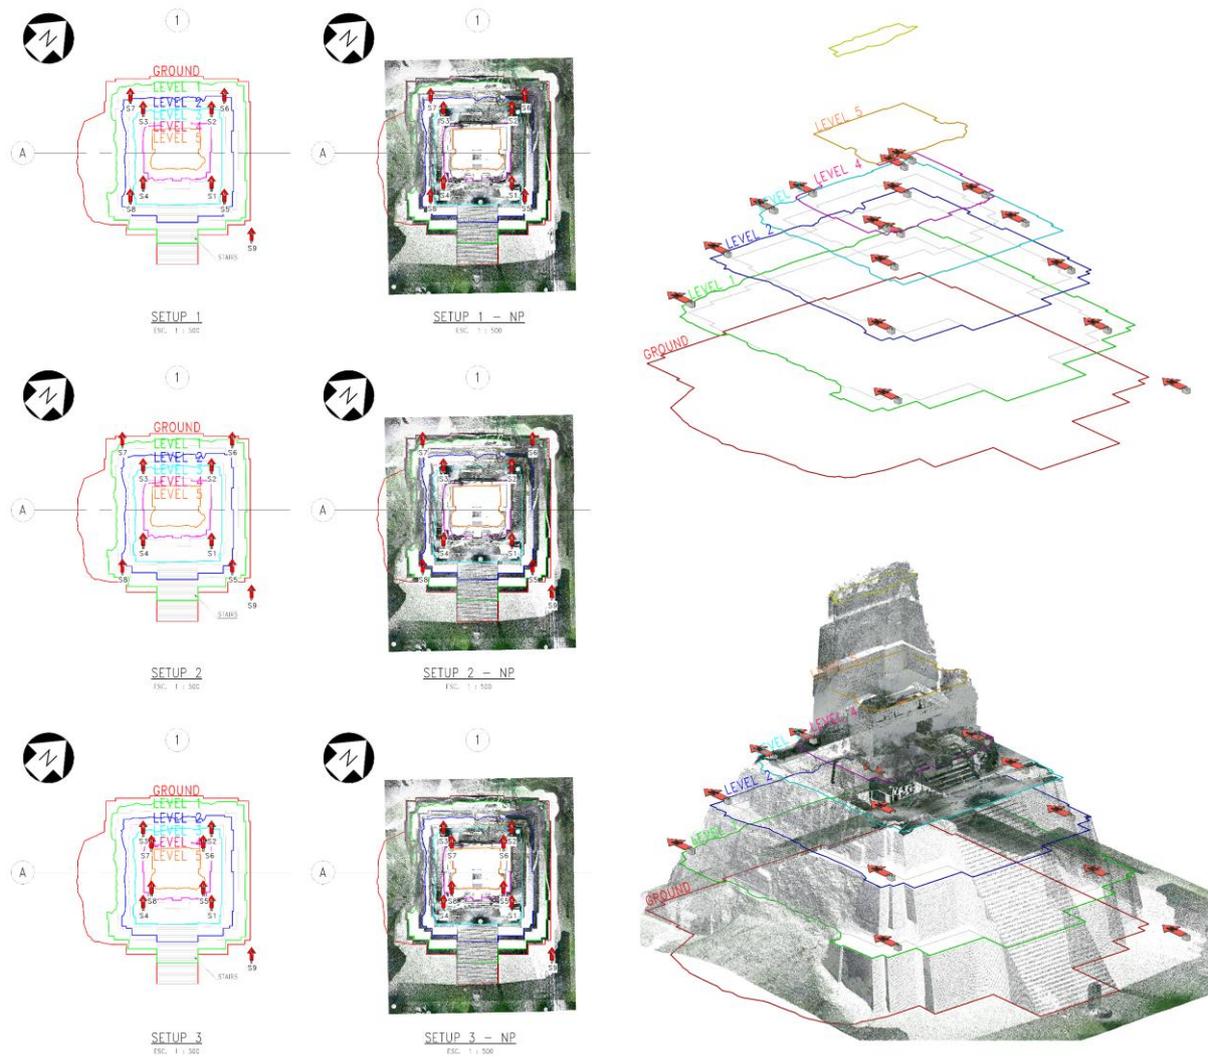
A series of ambient vibration tests were conducted at the temple to determine their dynamic modal properties. Nine portable-wireless sensors [14] were used for these tests. The testing program consisted of three measurement setups. The layouts of the sensors are illustrated in Figure 2. For all configurations, five out of nine sensors were considered as reference: four at level 3 and one at the ground level. The remaining four sensors were placed at level 2 for setup 1, at level 1 for setup 2 and level 4 for setup 3 as rovers. The duration for all setups was 20 minutes at 128 Hz.

Figure 2. Setup 1 to 3. Ambient vibration test setup (velocity).

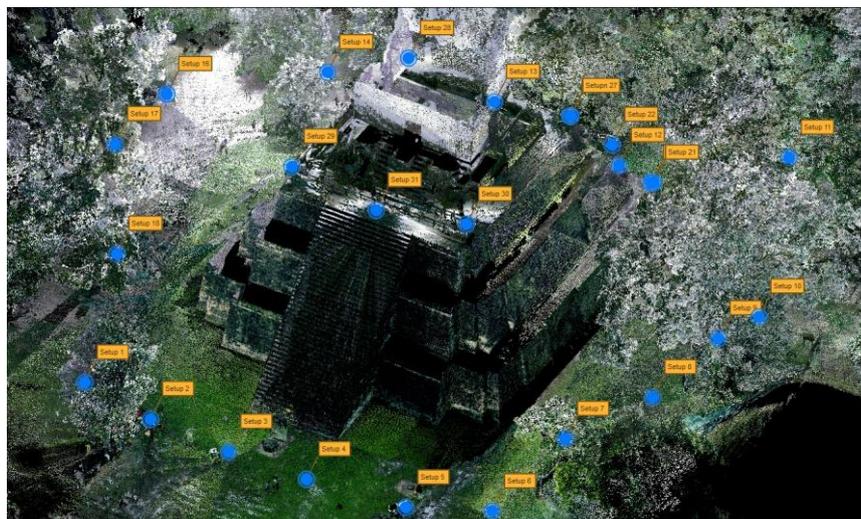
A laser scanning survey was conducted around the entire perimeter of the pyramid to achieve a detailed three-dimensional model based on a point cloud. Thirty-one positions were performed using equipment capable of capturing 360,000 points per second, ensuring high-resolution data collection (Figure 3). This technique enabled the accurate capture of the pyramid's geometry, including its external contours and structural features. The point cloud data was processed to generate a 3D representation, considered as a reference for further structural and geometric analysis. Additionally, the laser scanning data was utilized to monitor the verticality of the pyramid by assessing any deviations from its theoretical vertical axis. This evaluation provides critical insights into potential tilting or leaning of the structure. Furthermore, the survey was employed to detect and quantify differential settlements, which may affect the stability and integrity of the pyramid. By combining geometric modelling with monitoring these

Figure 3. Laser Scanner Positions during survey

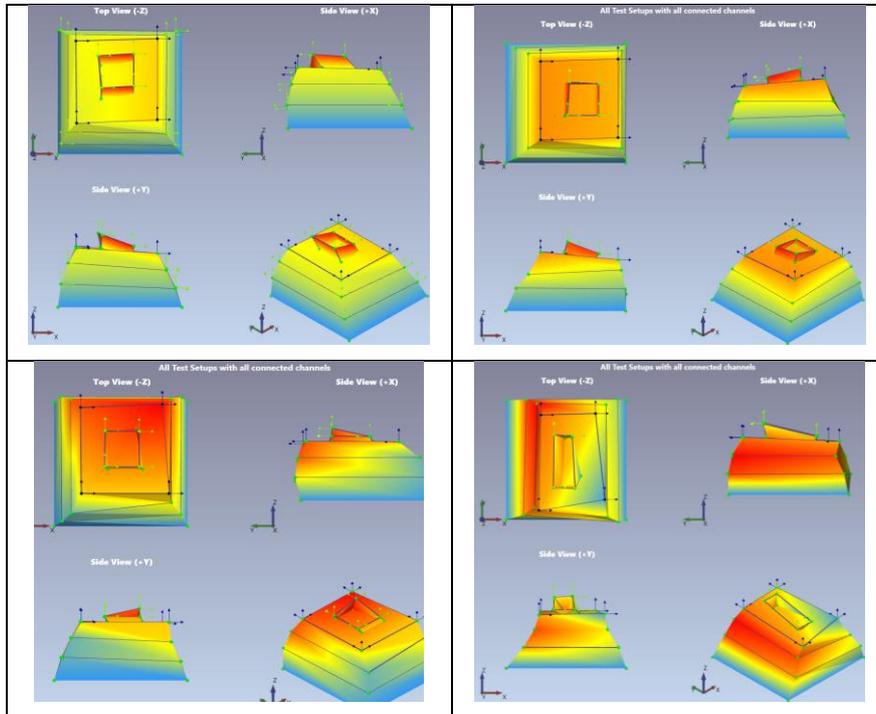
Well-established techniques were employed in both the frequency and time domains to obtain the dynamic parameters of the temple. The Enhanced Frequency Domain Decomposition (EFDD) was used for the frequency domain. For the time domain analysis, the Stochastic Subspace Identification (SSI) approaches—Unweighted Principal Components (UPC) and Canonical Variate Analysis (CVA)—were applied. All the analyses were developed using the ARTeMIS Modal software [15]. The results obtained from these analyses are presented below.

Figure 4. Modal Shapes. Upper-left: $f=4.07$ [Hz], upper-right: $f=4.25$ [Hz], down-left: $f=5.30$ [Hz], down-right: $f=5.94$ [Hz]. ARTeMIS Modal [15].

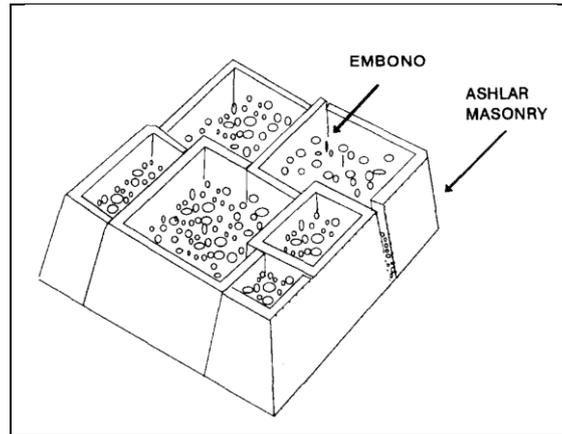
According to the study by García de Miguel et al. [12], the structure of the Great Jaguar Pyramid, close to the Temple II consists of ashlar masonry walls filled with “*embono*”, a lime mortar with local limestone fragments, forming a solid system with minimal voids. The fine-grained limestone used in the masonry is highly porous, making it susceptible to erosion and biological growth. While the study conducted by García de Miguel et al. [12] focuses on the Great Jaguar Pyramid, its findings are extendable to Temple II, as both share the same construction techniques and materials. The deterioration processes identified, such as loss of “*embono*” cohesion and limestone degradation, are also likely present in Temple II, providing valuable insights for its study and conservation

Figure 5. The schematic material structure of the Temple. [12]

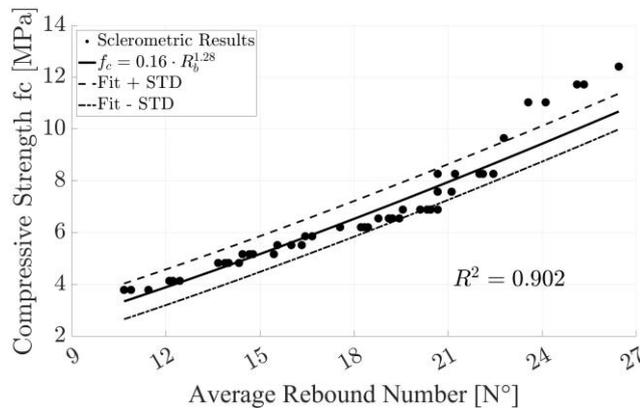
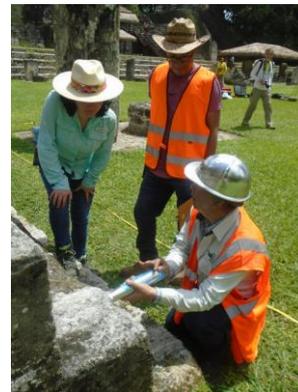
The results obtained during the assessment of the Temple II from Schmidt hammer (sclerometric) indicate an average compressive strength of 6.6 MPa, which correlates acceptably with the study developed by Krzan et al. [13]. However, as shown in Figure 6, a high heterogeneity is observed, with values ranging between 4 MPa and 12 MPa. This variability is also consistent with the study conducted by M. Krzan et al. [13], supporting the establishment of a correlation between rebound number and compressive strength.

Figure 6. Left: Sclerometric results and correlation equation between rebound number and compressive strength. Right: Schmidt Hammer Test on-site.

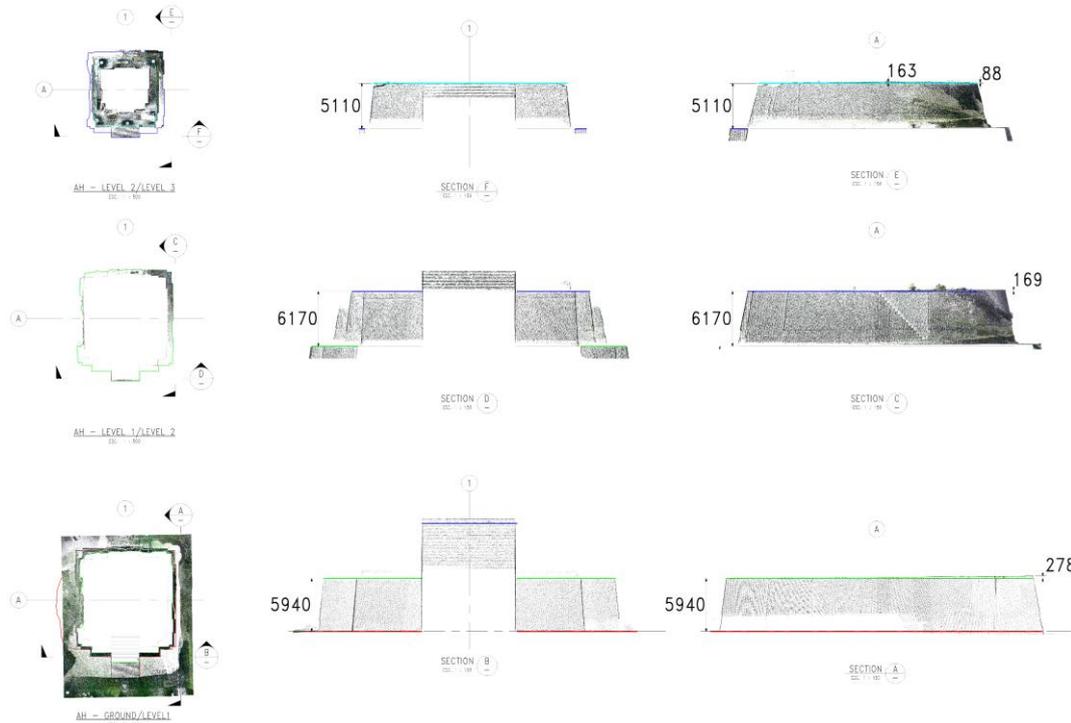
A key finding from the analysis was the identification of differential settlements (or rocking) within the pyramid. These settlements were quantified across its structural blocks, revealing a progressive decrease in settlement values from the base to the upper sections. Specifically, the first block (base) exhibited a differential settlement of 278 mm, the second block (between level 1 and 2) 169 mm, and the third block (between level 2 and 3) 68 mm. These differential settlements must be considered for a structural evaluation. In the opposite direction, no differential settlements were found.

Figure 7. Estimated rocking between pyramid blocks using 3D laser scanning. Up: upper block, between level 3 and 2. Middle: middle block, between level 2 and 1. Down: ground block, between level 1 and ground.

The findings highlight potential risks associated with differential settlements, suggesting the necessity of long-term monitoring. These preliminary evidence also emphasize the need for a more representative characterization of the strength of the structural materials and continuous and long-term monitoring of the temple’s dynamic properties and verticality. A more detailed assessment of the potential soil-structure interaction is recommended to better understand its influence on the observed settlement patterns and overall structural stability.

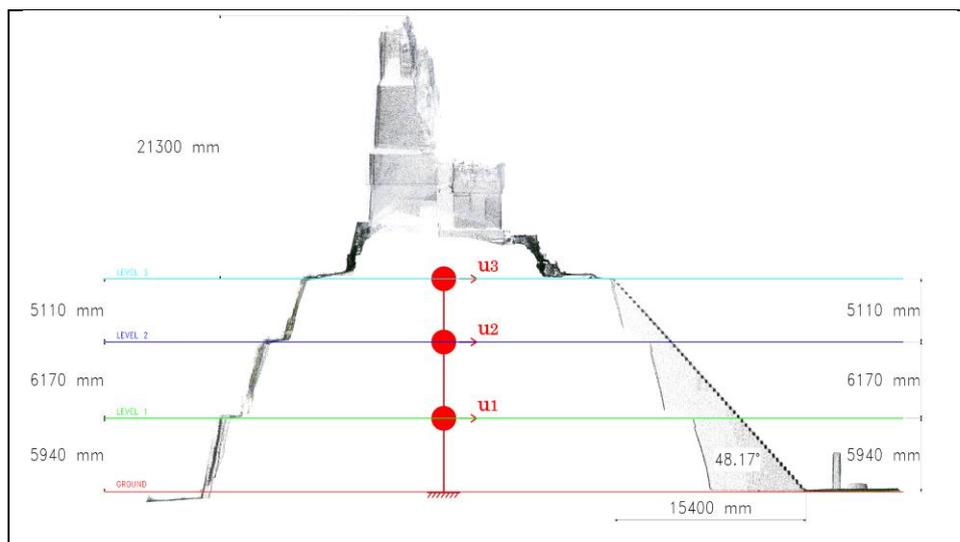
One of the most common applications following a structural assessment and SHM analysis is the calibration of a mathematical model to evaluate the structural condition. A structural model also enables simulations to assess performance under events like earthquakes, soil effects (e.g., liquefaction), extreme climatic events (flood, hurricanes, etc.) or even degradation over time. In this case, a simplified three-degree-of-freedom model was developed, incorporating the geometric and estimated strength results. An extra mass corresponding to the pyramid's crowning was included in the system to account for its influence on the dynamic behavior.

Figure 8. Simplified model scheme (2-D, three displacement DOF)

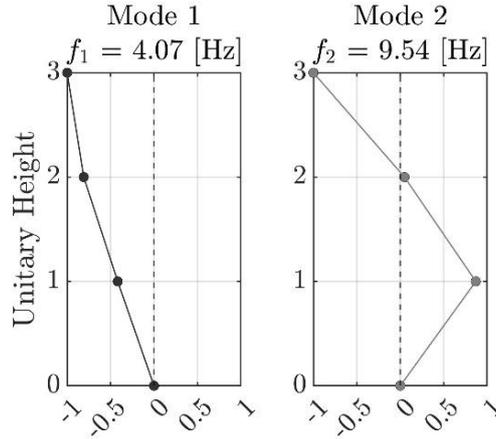
Lateral Stiffness was assumed given only by shear stiffness calculated as $K_s = \frac{G_c \cdot A_s}{3h}$. A comparison between the natural frequencies and mode shapes identified from experimental measurements and those obtained from the preliminary simplified model is presented below, with the aim of establishing an initial benchmark for the development of a more refined and comprehensive numerical model. Table 4. Comparison between model and ambient vibration test results.

Figure 9. Modal shapes (2D). Simplified Model (3-DOF).
