International Operational Modal Analysis Conference

20 - 23 May 2025 | Rennes, France

OMA of a School Building Damaged by the Illapel Earthquake (Chile 2015)

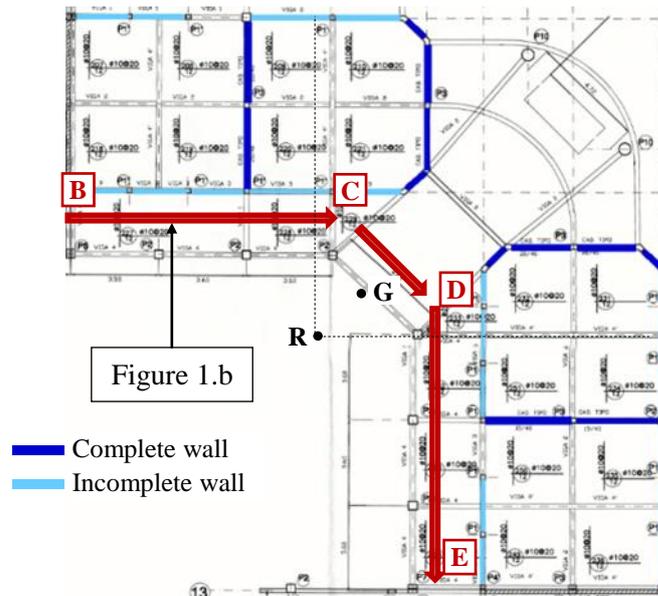
Figure 2. Structural plan layout of the second story of the central wing (Illapel)

Figure 2 displays a more detailed plan view of the structure and the infill walls of the central wing 2nd story; the complete/incomplete walls (reaching/not reaching the story height) are represented in dark/light blue.

Figure 2 shows the approximate positions of points R (center of rotation, or rigidity) and G (center of gravity) of the second story; they are determined using the numerical model described in section 5 (for the undamaged building but with the cracked members). As for R, its position is selected mainly based on the complete walls (dark blue); as they are oriented in orthogonal directions, that point is located at the intersection between the center lines parallel to walls in NW and NE directions. As there is an important eccentricity between points R and G, the central wing has a great asymmetry in plan. Therefore, a relevant torsion motion is to be expected; this can be understood as a rather poor seismic design. Finally, the red arrows describe the itinerary (B-E, Figure 1.b) of the inspection tour, including the most severe damage observed.

between the centers of mass and of rotation displayed in Figure 2. Regarding the other columns, Figure 3.d shows that the second column had a shear failure; the separation of the stirrups in the affected segment was particularly high. Analogously, Figure 3.e and Figure 3.f confirm that the third and fourth columns also failed due to shear, although without breaking the transverse reinforcement.

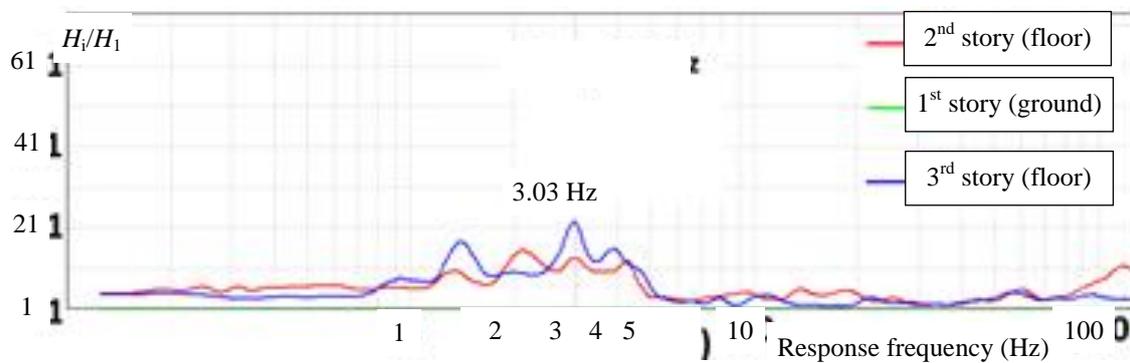
(a) NS direction (Figure 1.b)

The important amplifications in Figure 4 indicate that the building is highly flexible in the horizontal directions; the estimated building’s natural frequencies corroborate this. This estimation (from the plots in Figure 4) is far from obvious due to the uncertainties involved in the measurements and, mainly, to the difficulty in distinguishing the peaks corresponding to the natural frequencies of the building (for global vibration modes) from those referring to either local modes or input frequencies. Regarding this latter issue, it is assumed that peaks that appear simultaneously (i.e., for the same frequency) in the 2nd and 3rd stories correspond most probably to a global mode in the considered lateral direction.

- **NS direction.** The plots in Figure 4.a exhibit the highest peak (in both stories, H_2/H_1 and H_3/H_1) for a frequency approximately equal to 3.03 Hz (period 0.330 s); as the spectral amplitude is

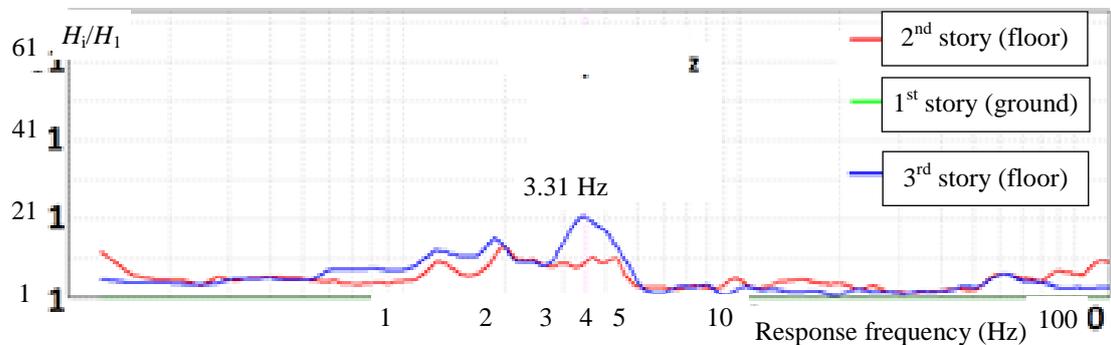
(b) EW direction (Figure 1.b)

- **EW direction.** In the EW direction, the highest peak of the plot in Figure 4.b corresponds to a frequency approximately equal to 3.31 Hz (period 0.302 s).

Comparison between the periods in both directions shows a high similarity; this matches the information in Figure 2.

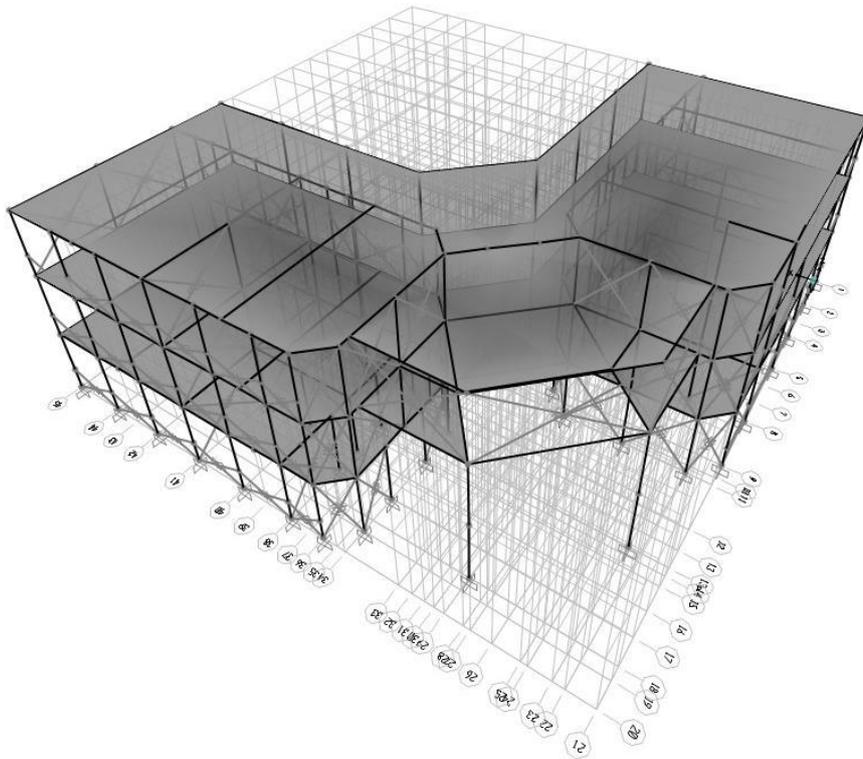
Figure 5. Numerical model of the central wing of the “San Rafael de Rozas” school building

Figure 5 shows that the model includes the main structural and non-structural elements, namely columns (even the short ones), slabs, and masonry infill walls; as only the short columns and the complete walls (those spanning the free height of the story) exhibited relevant damage, their behavior is modeled as nonlinear, while that of the other members is linear.
